Miramar Water Treatment Plant Upgrade and Expansion Construction Update July 2009

Contract B (Please see photo at end)

Contract C (Please see photo at end)

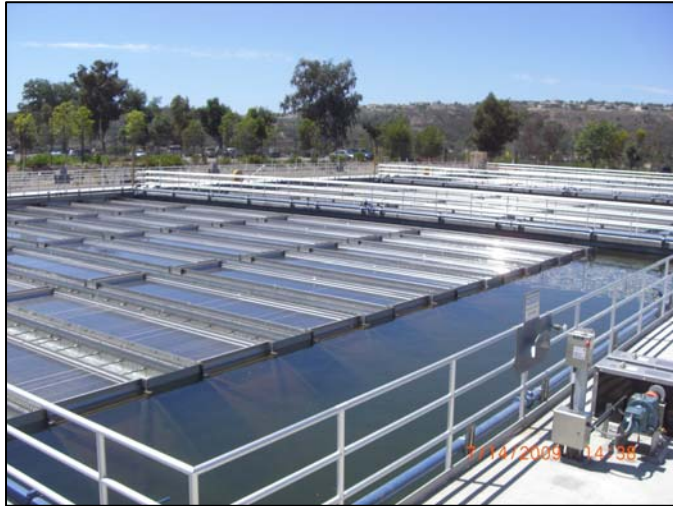
Photo explanation:

New sedimentation basin 6 is in the central foreground of this photo. The plate settlers are visible on the top of the basin and appear to nearly cover the top of the basin. The plate settlers help the unwanted particles in the water sink to the basin floor where they can be removed. New sedimentation basins 7 and 8 are visible in the upper middle and right side of the photo. (Photo July 14, 2009)

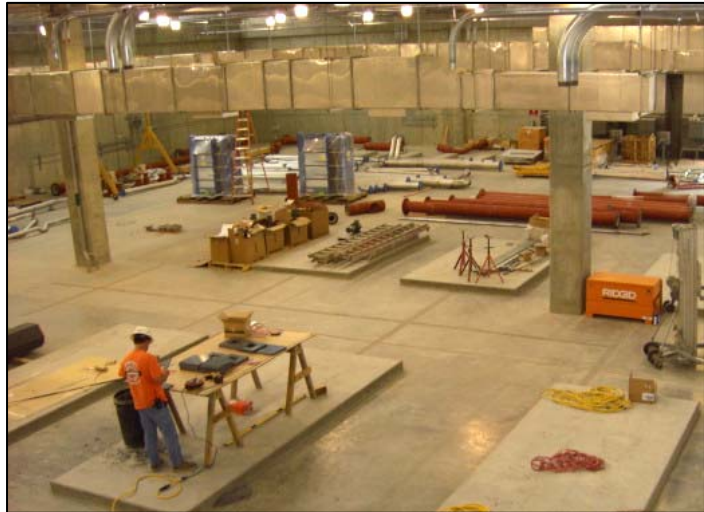
Photo Explanation:

As piping and equipment arrives, it is stored in the ozonation building generator room. Later it will be assembled and connected to the ozonation equipment. The ozone generators will be placed on top of the concrete pads visible on the floor. (Photo June 30, 2009)

- The ozonation equipment is being installed in the underground ozonation building, which at this time somewhat resembles a large, underground parking lot.

- The contractor has installed the concrete pads which will support the liquid oxygen tanks and electrical conduits for the new equipment. Piping for the ozonation system is arriving and being installed in the ozonation building.
